Inspection Report

Any Street

Lewiston, ME 04240

Prepared by: RPR Professional Home Inspections Inc.

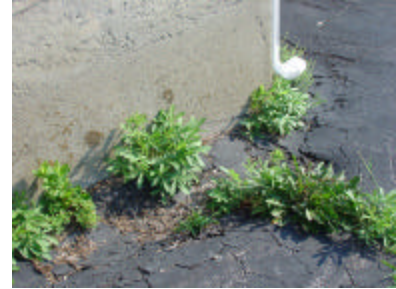
CONDITION: APPEARS SERVICEABLE Most cracks noted are typical, a few Cracks noted are major.

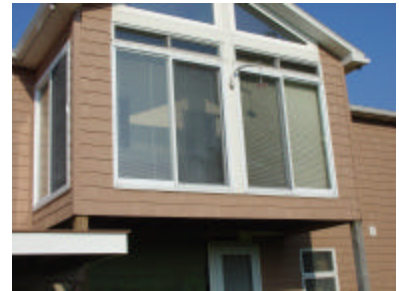
CONDITION: APPEARS SERVICEABLE *****No Railings - Handrail are required for all platform that are 30 inches or higher off the ground.**

STAIRS: There are no stairs leading from the porch to the deck.

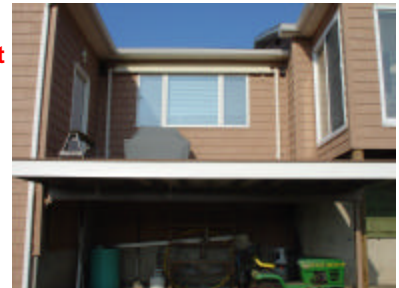
CONDITION: APPEARS SERVICEABLE *****Handrails are needed. Hand a required for all platform that are 30 inches or higher off the ground.**

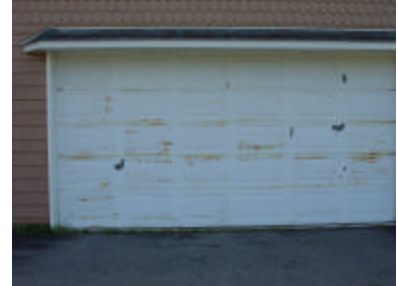
CONDITION: OPERATIONAL All door(s) were functional and operated smoothly, [Needs Painting](#).
